NASA Technical Paper 1210

Light Airplane Crash Tests at Three Flight-Path Angles

Claude B. Castle and Emilio Alfaro-Bou

JUNE 1978

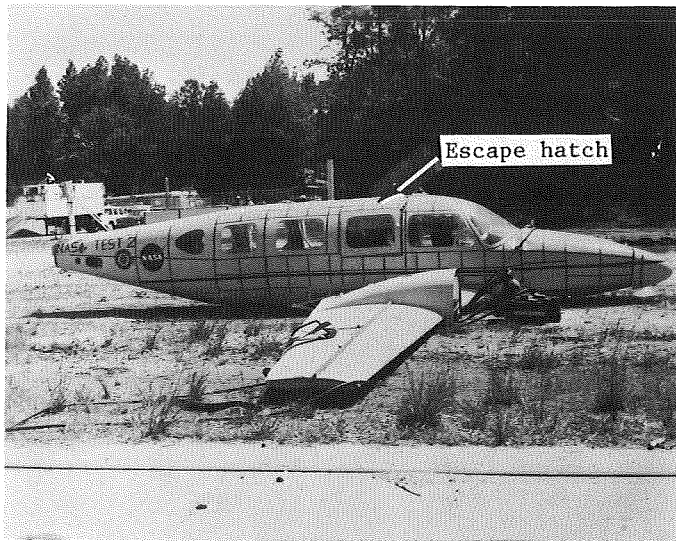
The exterior damage to the -15° test specimen is shown in figure 10. As seen in the overall view of the right side (fig. 10(a)), buckling occurred in the nose section, at the fire wall, and along the bottom of the fuselage. As shown in figures 10(c) and 10(d), there is rivet shear across the top of the fuselage aft of the pilot and copilot. Also, rivet shear is evident aft from the escape hatch along the window ledge and downward at the rear of the third window. (See figs. 10(a) and 10(b).) The breaking of the pilot's windshield and side window was due to deformation of the forward cabin section (fig. 10(a)).

(a) Overall view of right side.

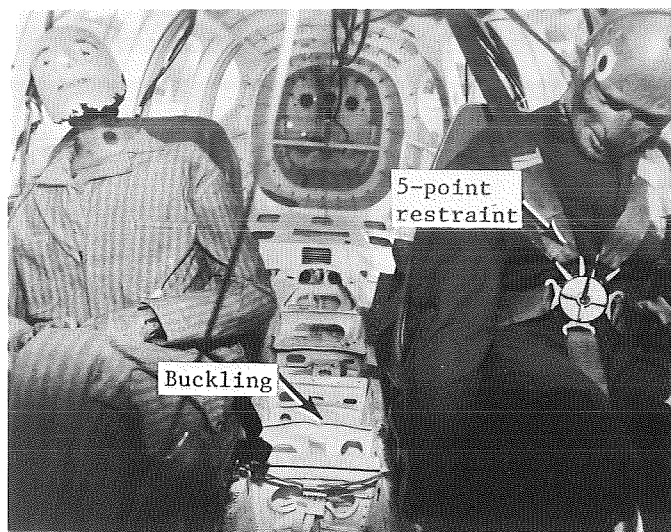
Damage to the cabin interior is shown in the four photographs of figure 11. The first photograph (fig. 11(a)) is a view looking aft from the cockpit where buckling can be seen in the stiffeners which tie together the two main floor beams. Figure 11(b) is a view looking forward from the tail section and again show the main floor beams and the buckled stiffeners. The four photographs of figure 11 also show the layout of seats, dummies, additional masses, and instrumentation equipment. The apparent upward movement of the floor section is shown by the outward rotation of the seats. The view looking through the doorway, figure 11(c), and the view of the cockpit, figure 11(d), show moderate interior damage.

(a) View looking rearward.

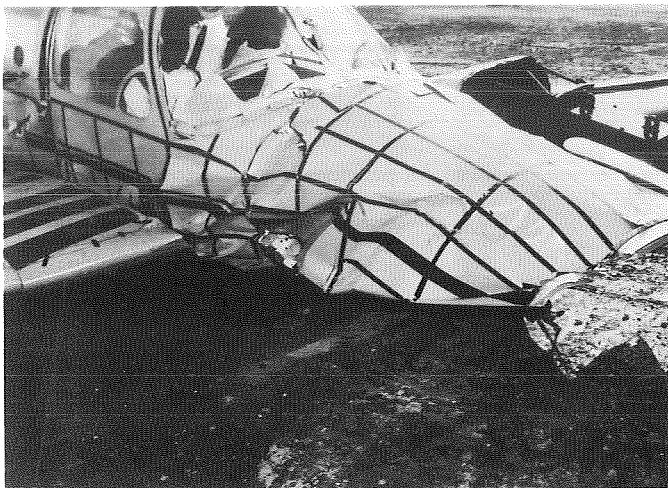
The exterior damage resulting from the crash is shown in figure 13. A view of the right side and nose section shown in figure 13(a) shows severe structural damage to the nose section, broken windshield, rivet shear, and cabin separation in the vicinity of the main spar aft of the pilot and copilot. Figures 13(b) and 13(c) are closeup views of the cabin on the right side, and figure 13(d) is a closeup view on the left side. Due to rivet shear, separation of the airframe occurred on the right side along the vertical edge of the emergency escape hatch (figs. 13(b) and 13(c)) and directly opposite on the left side (fig. 13(d)). There is rivet shear and skin separation across the top of the cabin at the rear of the escape hatch, and there is skin buckling along the roof of the cabin. Figure 13(d) shows the left side of the -30° test specimen and the cabin separation along the window ledge, the broken windows, and the collapsed nose section. The windshield center post was fractured. The deformation, tearing, and buckling of the nose of the test specimen are quite visible. Aft of the fire wall, a livable volume was maintained inside the cabin.

(a) View of right side and nose.

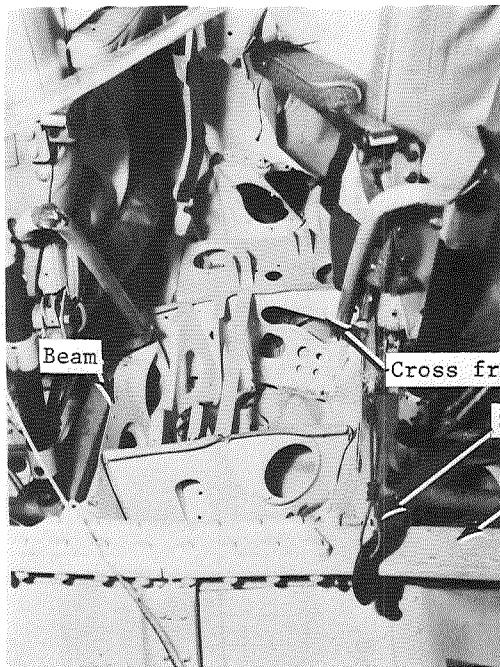
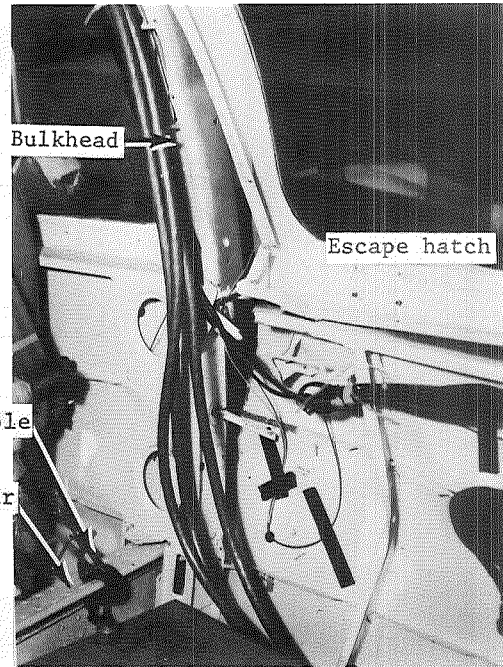
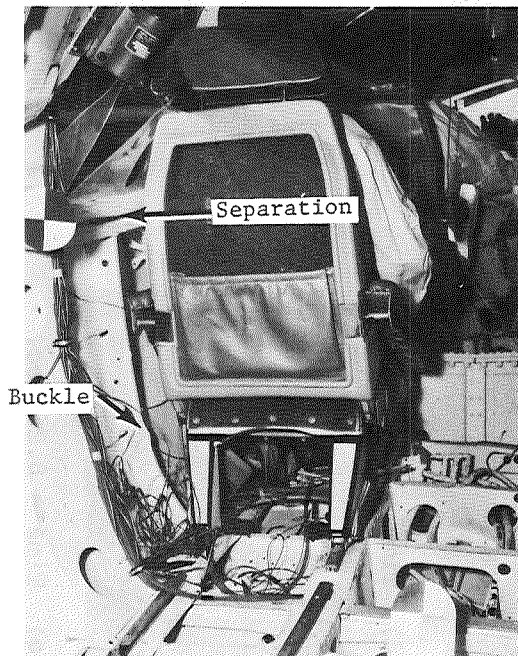
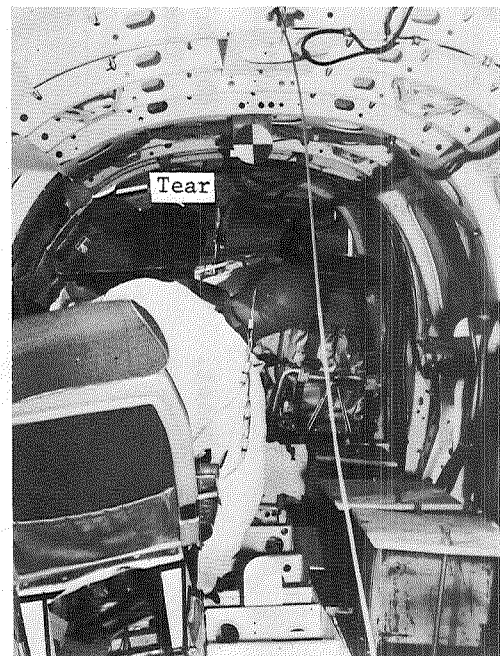
The interior damage to the -30° test specimen is shown in figure 14. The view looking forward from the main spar (fig. 14(a)) shows the upheaval of the floor between the pilot and copilot, with deformed cross-frame and beam-member floor supports. The crew seats remained attached to the floor although the seat support structure on the pilot seat was broken. The steel cable attached to the copilot seat did not contribute to the support of the seat but was a precautionary measure to restrain the seat and dummy had the seat detached from its floor mounts. The separation of the skin along the cross-frame member in back of the main spar is shown in figure 14(b); this view is looking forward at the right side of the test specimen, with the displaced window being the emergency escape hatch. The floor and left side of the airplane in the vicinity of the first passenger are shown in figure 14(c). The floor cross-frame supports are bent but attached, and there are buckles in the cross frame about seat-pan level along the left side. Also shown are the broken passenger window and the separation of the cabin along the window level. Figure 14(d) shows an overall view looking forward from the area behind the door. The third-passenger seat was deformed because of the apparent upward movement of the floor during the tail slapdown. (See fig. 12(h).) The cross-member supports between the two main longitudinal floor beams pulled loose from the left beam (fig. 14). In the first-passenger location, the forward movement of the dummy produced a sufficient load on the shoulder restraint system to cause tearing of the airframe structure supporting the inertial reel.

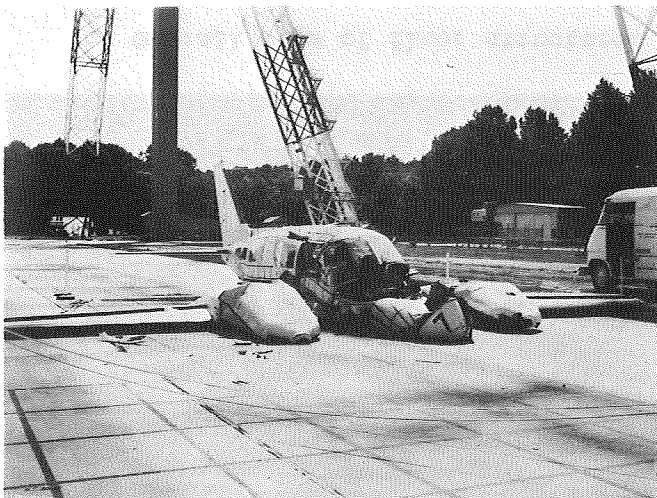
The crash damage to the exterior of the -45° test specimen is shown in figure 16. An overall view of the right front side of the airplane is shown in figure 16(a) which shows the nose demolished, the windshield broken, the windshield post broken both in the center and right side, the damaged nacelle covering, and the crease across the top of the cabin section where inward folding of the roof section has taken place. Figure 16(b) is a closeup view of the right side and shows the wing-to-cabin deformation, the breakaway of the emergency escape hatch, the separation of cabin and nose section at the fire wall, and the fuel leakage. Fuel leakage occurred in both fuel tanks because of the wing structure piercing the fuel bladders. Figure 16(c) shows the cabin section from the left side and shows the fracture of the left windshield post and collapse of the first main-section frame at window level. Also shown is rivet shear along the window ledge and across the top of the cabin. Figure 16(d) is another view of the damaged cabin discussed in the previous figure (fig. 16(c)) and clearly shows the roof crease. Safety glass was used on the left windshield and plexiglass was used on the right windshield. The fragmentation pattern for both sides is shown in figure 16.

(a) Overall view of right front side.

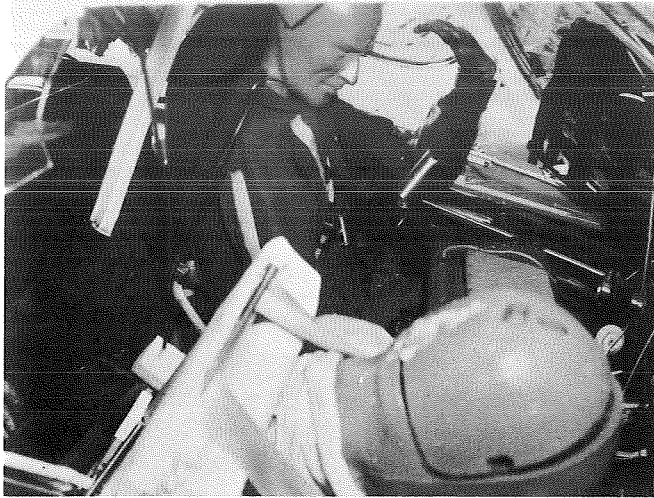
Interior cabin damage to the -45° test specimen is shown in figure 17. A view of the pilot and copilot section of the cabin (fig. 17(a)) shows the instrument panel displaced upward and the control wheel shaft broken, with the control wheel bearing on the pilot's chest. The roof impacted the head rest on the pilot seat to deform it forward, causing the dummy pilot's chin to rest on its chest. The upheaval of the cabin-floor section thrust the dummy copilot forward into the instrument panel. Figure 17(b) shows a view through the cabin door looking at the rear of the third-passenger seat. The forward motion of the third passenger during impact caused the rear seat legs of the third-passenger seat to break loose from the seat rails, as shown. The seat back is broken and the dummy's arm is visible resting in the aisle. Motion-picture coverage of the interior (see film supplement) indicates that the third seat was broken during the second impact.

(a) View of crew and cockpit.

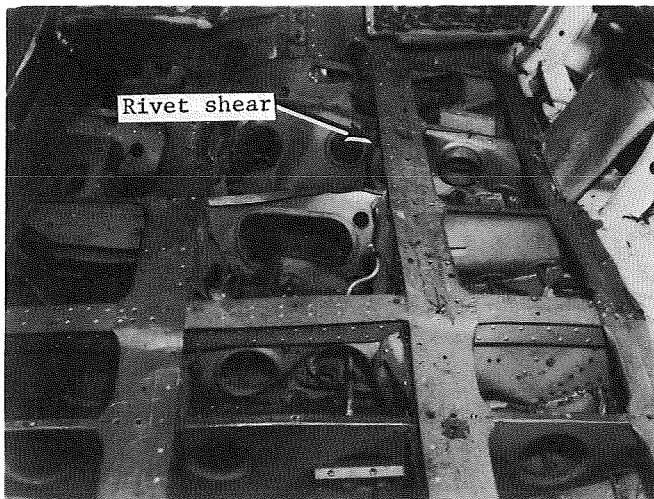
The type of subfloor structural failure can be seen in the overall (fig. 17(c)) and closeup (fig. 17(d)) photographs. In figure 17(c) is shown the rivet shear along the side wall and between the cross sheet-metal frames and the longitudinal floor beams. Tearing of the sheet-metal frames is evident along the entire length of the cabin area. The closeup view (fig. 17(d)) shows the sheared rivets lying on the outer skin and the mangled cross frame structure.

(c) Overall view of floor structure.

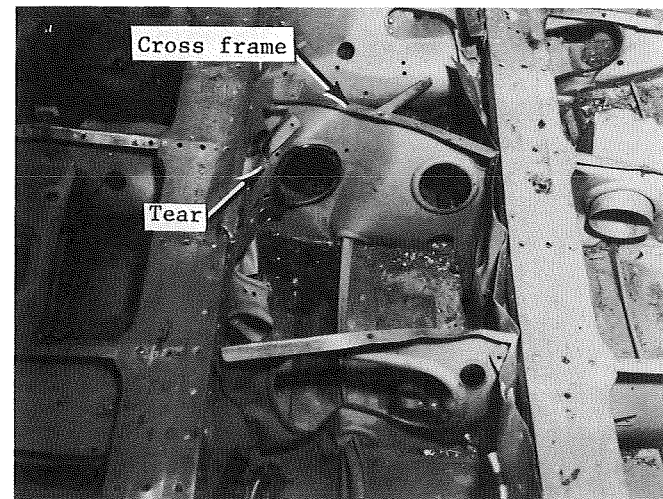
(d) Closeup view of floor structure.
